Cardno ATC

Client Name:	ADR Consultants – State of Michigan Fast Track Authority
Project Name:	Pre-Demolition Asbestos Inspections
Project Number:	39.43929.1304
Project Site Address (Subject Property):	1925 Central Street, Detroit, Michigan
Parcel #	
Date of Site Visit:	4/25/2013
Site Contact Name:	Barry Ellentuck
Site Contact Phone Number:	248-318-9424
Asbestos Inspection Performed by:	Branden Tincu (A39513)
Areas Not Accessible:	2 nd floor and some areas of 1 st floor due to fire damage
Number of Floors	2 plus basement & attic
Asbestos Present (Yes/No/Other)	No

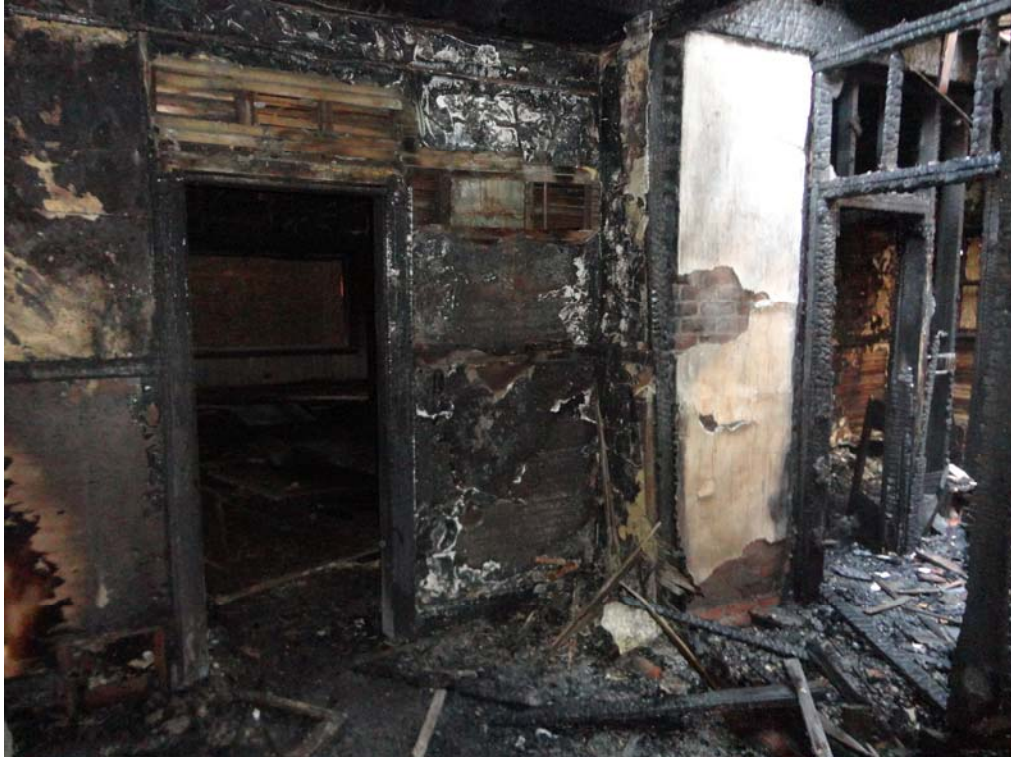
View of the house interior. Fire damage was present throughout limiting access to most of the house.

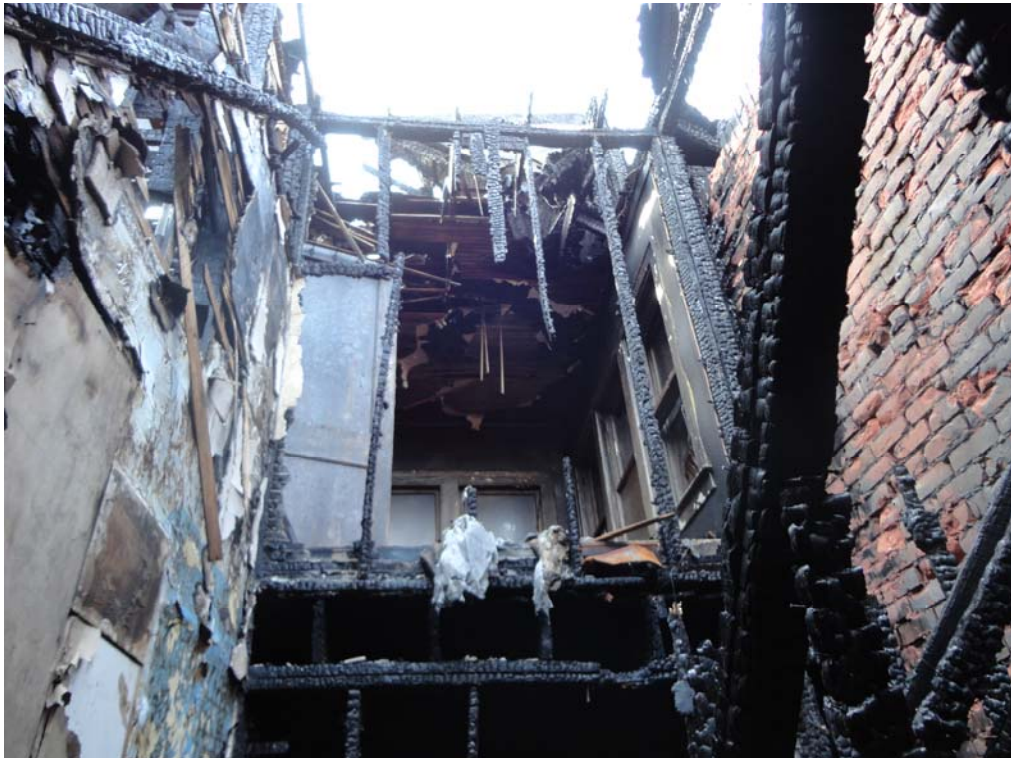
View of 2nd floor and rear stairwell from the 1st floor. The second floor was inaccessible.
