**ASBESTOS AND HAZARDOUS MATERIAL  
INVESTIGATION REPORT**

**5509 Philip  
Detroit, MI 48224**

Subject: Asbestos and Hazardous Material Investigation Report for 5509 Philip, Detroit 48224

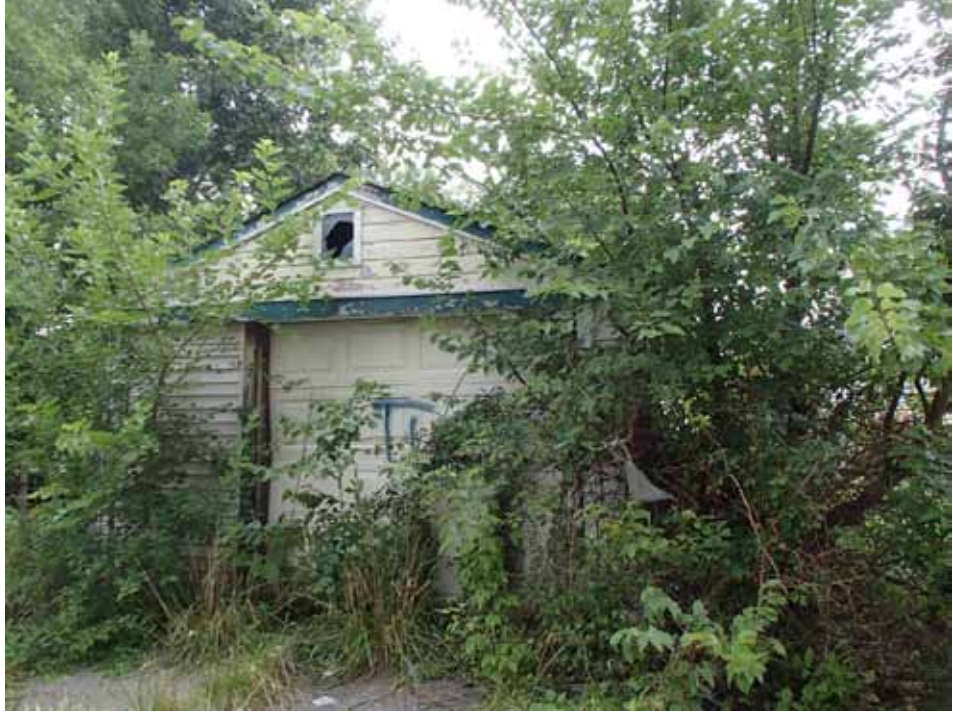
3				
Photographer:				Jef Fox
Date:				8/2/2014
Direction:				NA
Description:	View of garage			
Photo Number:

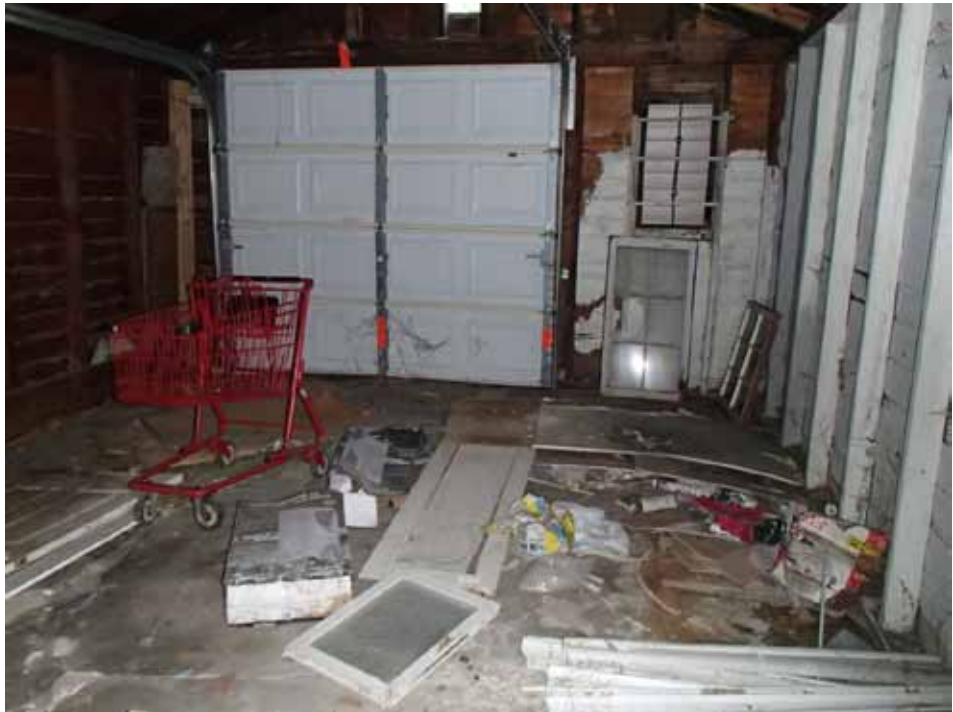
4				
Photographer:				Jef Fox
Date:				8/2/2014
Direction:				NA
Description:	View of garage interior

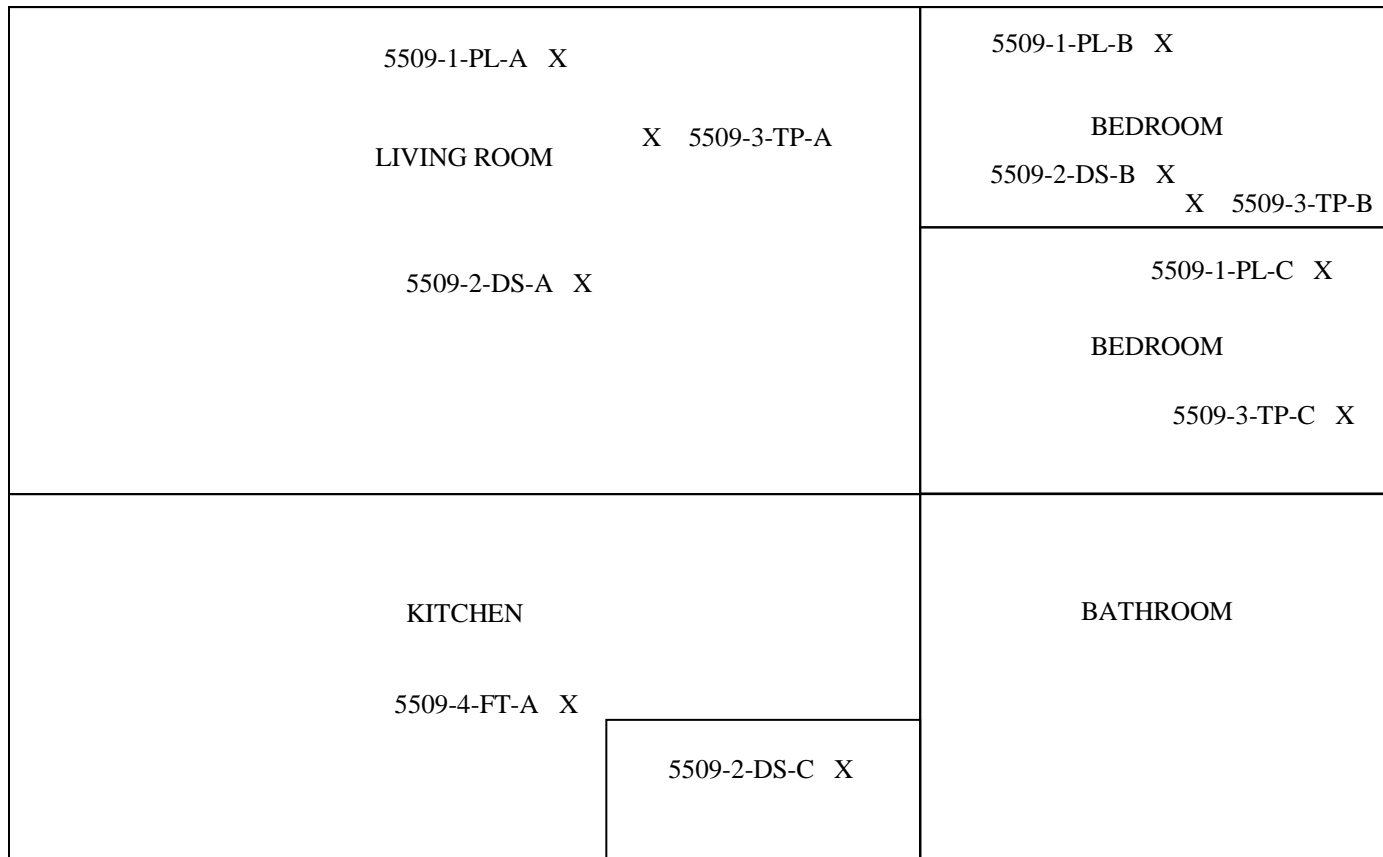
FLOOR PLAN 1 <sup>st</sup> FLOOR 5509 Philip Detroit, MI	CITY OF DETROIT  Michigan Land Bank	JOB# 07282014D	FIGURE #: 3
		DATE: 8/2/2014	DRAWN BY: Jef Fox

X 5509-5-WP-A

X 5509-6-SH-A
