PRE-DEMOLITION ENVIRONMENTAL INSPECTION SUMMARY REPORT

Parcel:	21021867
House No:	15313 Lappin, Detroit, MI 48205
Date Inspected:	6-21-2014
Inspected By:	Andre Richardson
	A-45125

ETC Job #: 155319

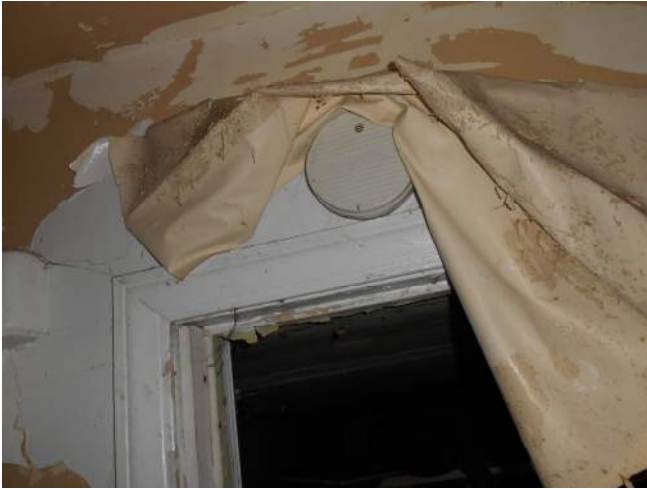
Material	Quantity & Units	Location
Smoke Detector	1	Kitchen 4

Smoke Detector, Kitchen 4

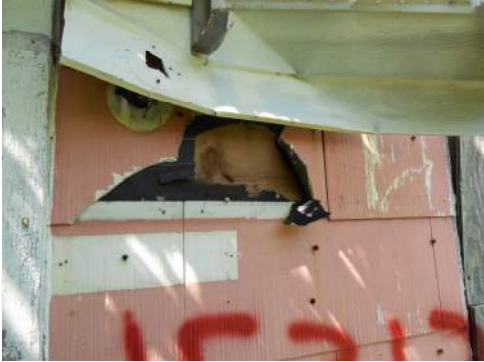
Material #	Material	Material Location	Estimated Quantity	ACM Present
1	Plaster	Rooms 1-7	2,500 SF	No
2	Drywall (including tape/mud)	Rooms 1-7	2,500 SF	No
3	Floor tile, 12 x 12, Grey & Brown, Peel n Stick	Kitchen 4	250 SF	No
4	Roof Shingles, Black	Home Exterior 9	1,000 SF	No
5	Roof Shingles, Black, Under Material 4	Home Exterior 9	1,000 SF	No
6	Roof Felt, Black, Under Material 5	Home Exterior 9	1,000 SF	No
7	Transite Siding, Red	Home Exterior 9	2,500 SF	YES
8	Fibrous Paper (under siding)	Home Exterior 9	2,500 SF	No

Red transite siding on home exterior
